UNITED STATES ENVIRONMENTAL PROTECTION AGENCY

Re: MS4 Inspection-Village of Scarsdale  
NPDES Permit No. NYR20A307

**MS4 Inspection Report/Village of Scarsdale, NY  
(NYR20A307) – November 26-27, 2012**

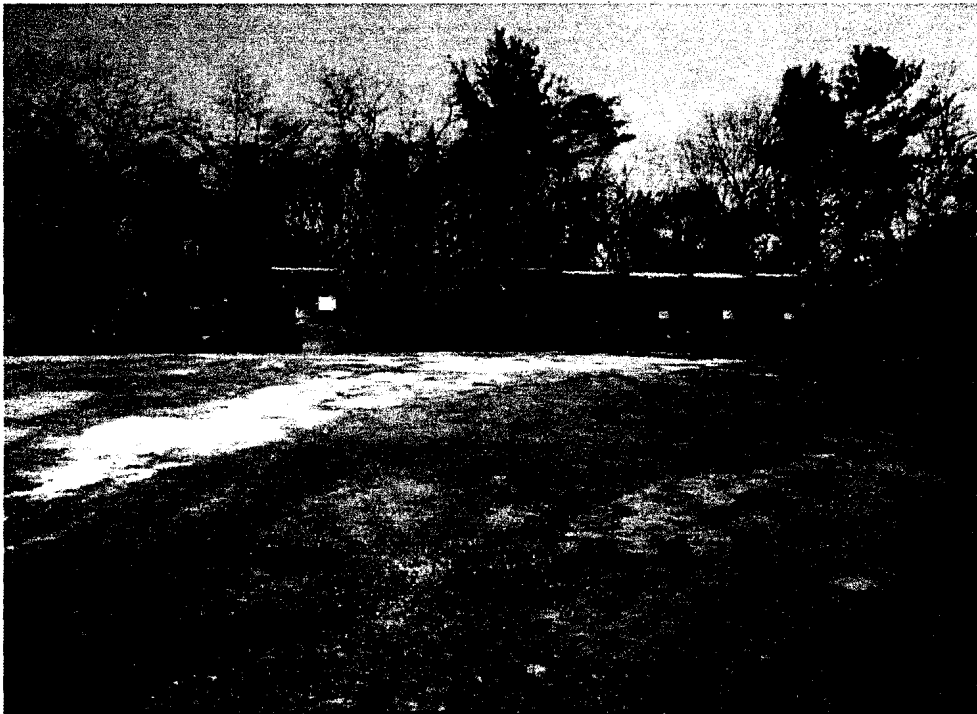
We observed tree cutting/mulching operations onsite, with approximately 4,000 tons of cuttings since Hurricane Sandy. At the materials/temporary storage area inspectors observed some washout/tracking of salt (de-icing) where salt is loaded and unloaded to vehicle spreaders. In this area piles of cold patch (asphalt) are stockpiled, and should be covered to prevent spillover.

Salt tracking during loading at materials storage area

1. Ensure that all flows from vehicle wash down areas are fully controlled by consolidating wash down to indoor garage locations only. All wash waters must be restricted to discharge to the sanitary sewer system.
2. Control of de-icing material spillage from loading vehicles should be restricted to a bermed area near the salt shed, rather than the current materials stockpile location to minimize tracking and exposure to the storm system due to rain events.
3. During bulk fueling operations (gasoline and diesel tanks), yard drains should be blocked to prevent contamination in the event of a spill.
4. Upon inspection of a catch basin on Greendale Road (adjacent to Green Field Park) inspectors noted a corrugated PVC pipe (apparently from a private dwelling) entering directly thru the top cover. In addition the metal of the catch basin was broken.

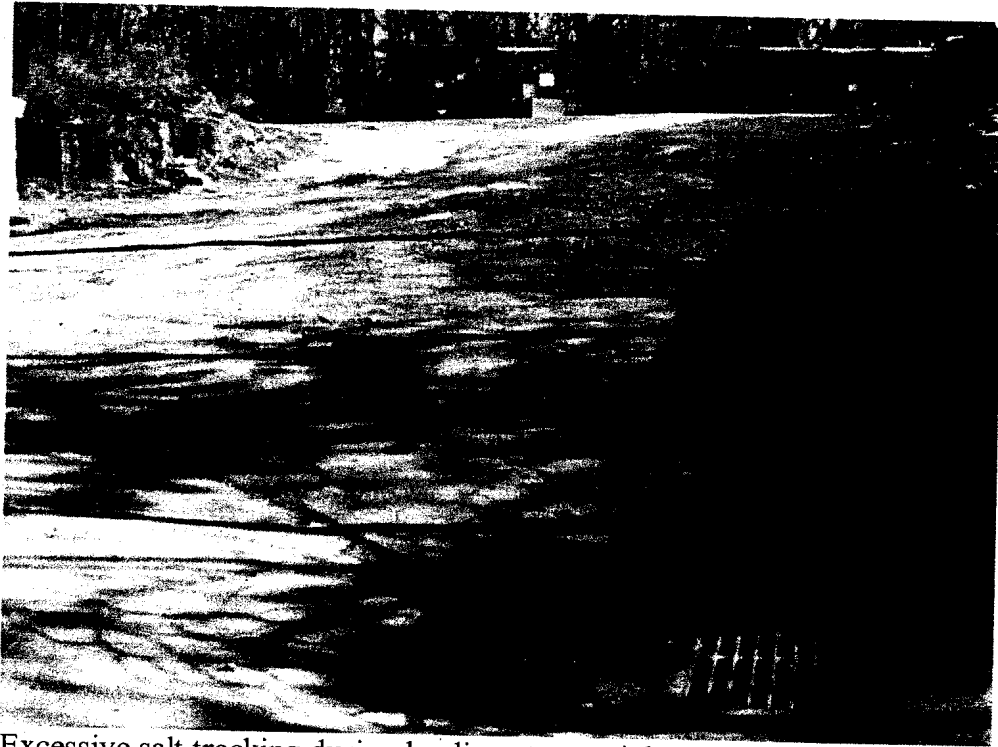
Excessive salt tracking during loading at materials storage area

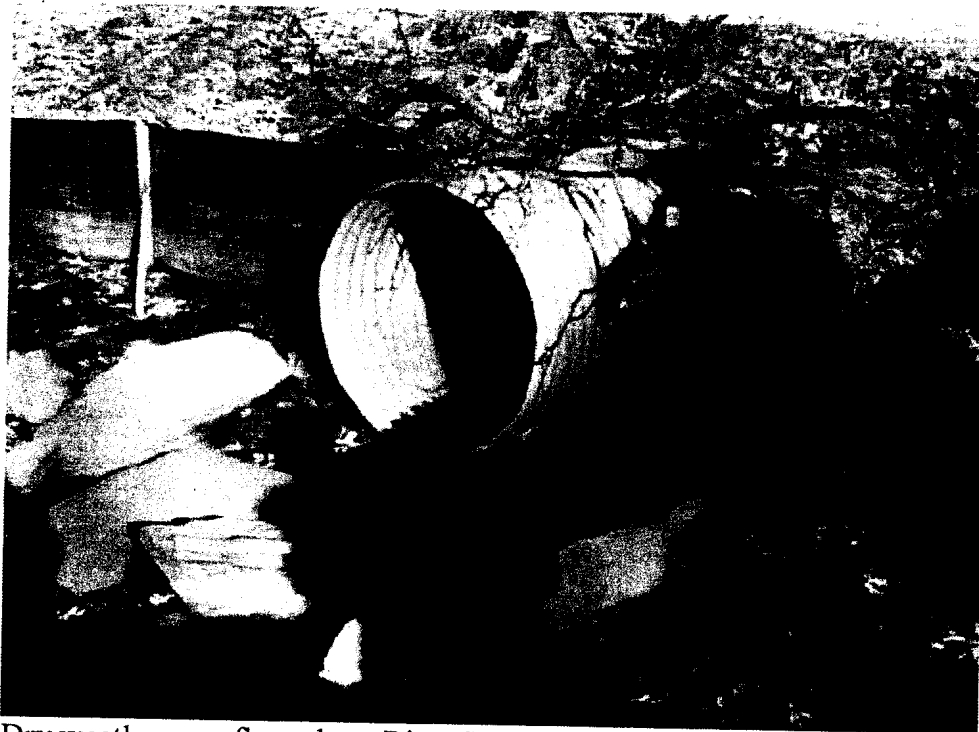
Outfall BR7, River Road, 36" corrugated metal, Latitude 40.990441 Long.-73.808778 9, flows drain from the downtown area

Dry weather overflow along River Road

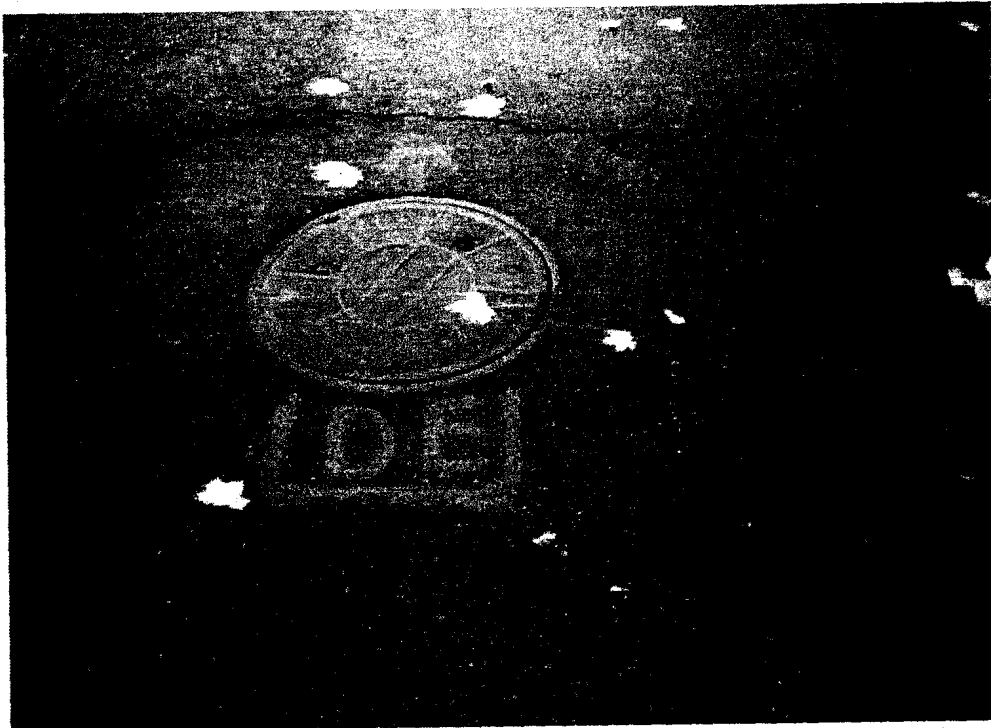
Outfall H3, 26 and 30 East Woods Road, Latitude 40.982755 Long -73.788876, 12" concrete pipe. At this location there existed a strong smell of sewage which is indicative of a surcharged or blocked sanitary line in the area. The storm water catch basins on this street should also be sampled, and service connection smoke/dye tested (if possible).

End of line sanitary catch basin with evidence of sewage break near 26 Eastwoods Lane

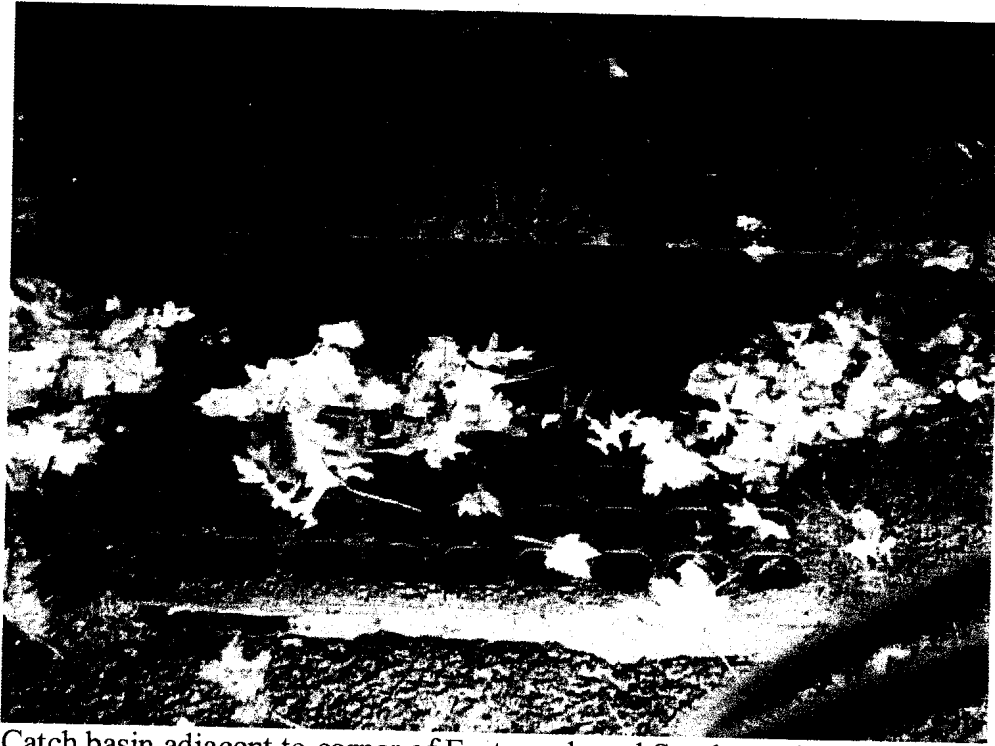
Catch basin adjacent to corner of Eastwoods and Southwoods Lane with strong sewer odor

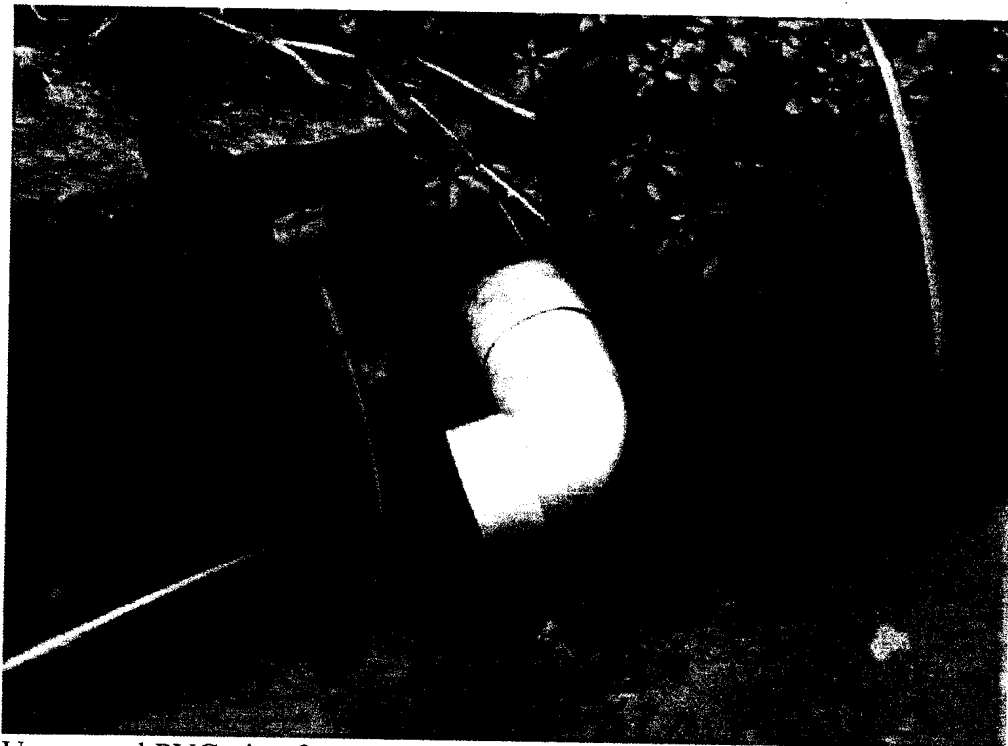
Outfall H2, #20 Forest near Drake, 36" concrete, Latitude 40.984866 Long.-73.787517, unmapped PVC pipes in the vicinity of this outfall

Unmapped PVC pipe from a residential connection to stream near Forest Lane & Drake Rd.
